A Structural Reevaluation of the Collapse of World Trade Center 7

Final Report

INE Report 18.17

March 2020

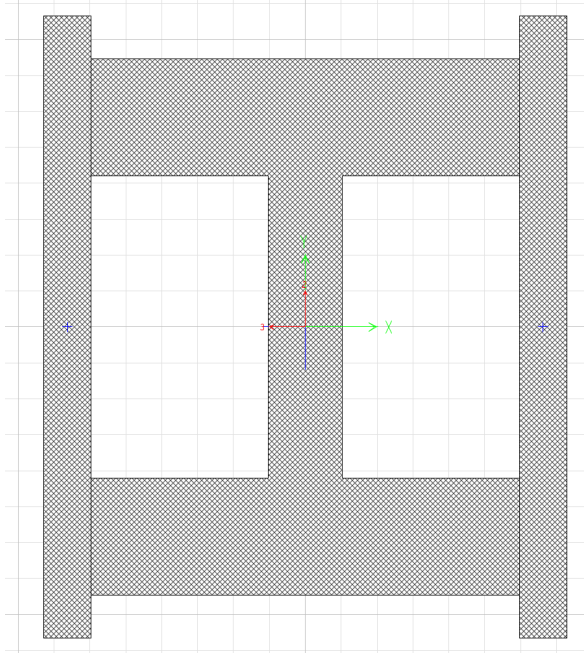
Figure 2.16 Cross section of Column 79.

Column 79 at Floor 13 was a built-up column consisting of W14×730 and two steel plates 2 inches thick by 26 inches wide welded on the sides. Figure 2.16 shows the cross section of Column 79. Figure 2.17 shows the mechanical properties of steel against temperature (Engineering tool box, 2011). A buckling analysis was conducted for Column 79 according to the AISC Steel Construction Manual (AISC, 2011). Figure 2.18 shows the load capacity of Column 79 versus the effective length at different temperatures assuming a pinned-pinned condition. The two red lines mark the effective length of 12 feet 9 inches and 25 feet 6 inches. The two effective lengths are the single floor height and the double floor height. The loading capacity of Column 79 at double floor height (25 feet 6 inches) would be the load capacity of the column during the fire if Column 79 were to lose its support on one floor. It is clear from Figures 2.17, 2.18 and Table 2.1 that the buckling load capacity was significantly higher than the acting load over a two-story unsupported length. Thus, a buckling failure due to vertical loading and heat caused by a fire could not have occurred.

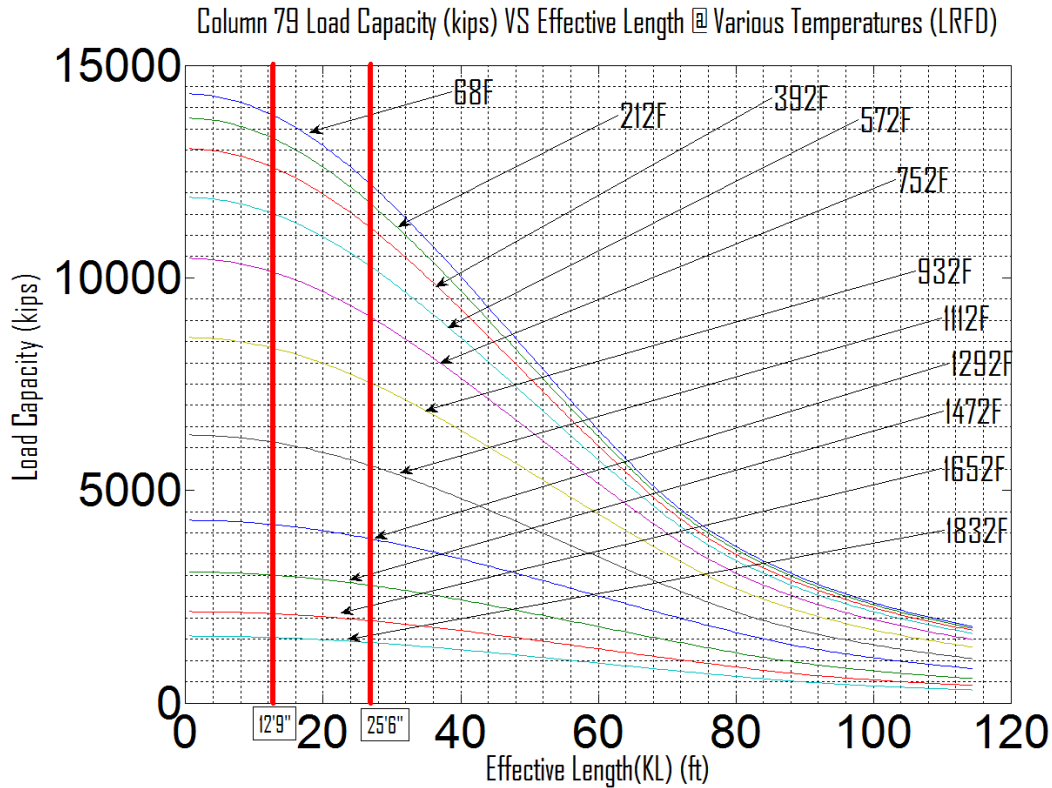
Figure 2.18 Load capacity of Column 79 versus effective length at different temperatures.

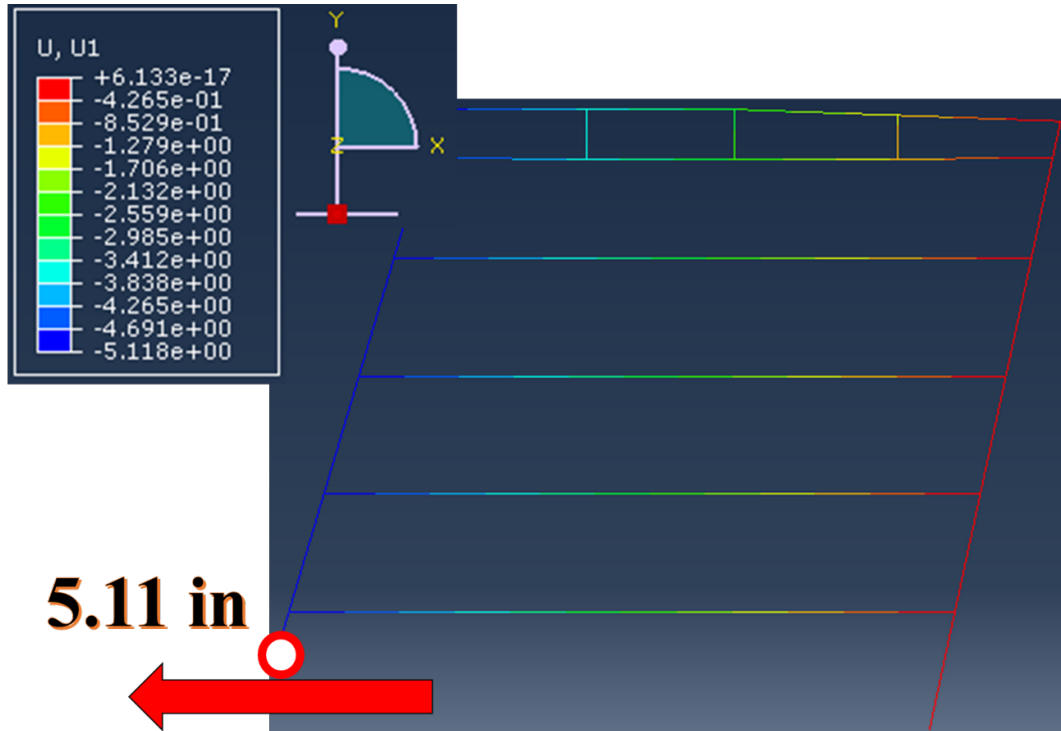
were not sufficient to displace girder A2001 to the point that it walked off its seat (the initiating failure alleged by NIST). Whereas NIST asserted that the differential westward displacement of girder A2001 relative to Column 79 was 5.5 inches and later revised its calculation to 6.25 inches, we found that the westward displacement of girder A2001 relative to Column 79 would have been less than 1 inch under the fire conditions reported by NIST.

Figure 2.66 Transverse displacement at the end of A2001 using the NIST assumptions.

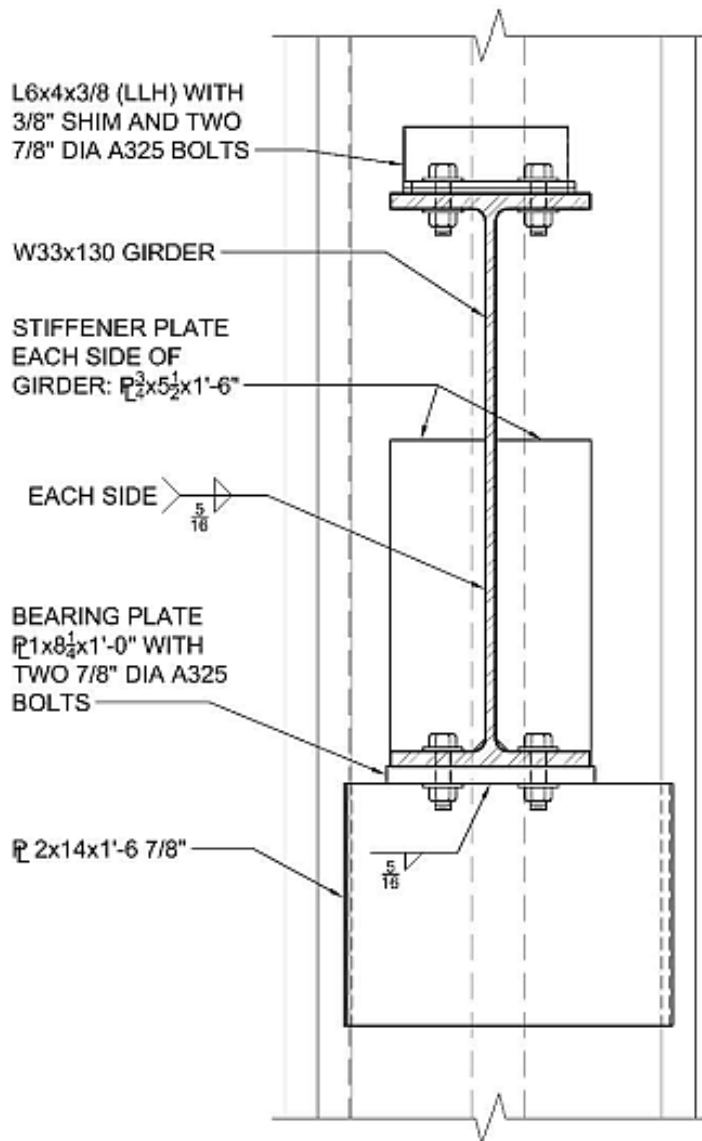
- NIST, by its own admission, did not include the partial height web stiffeners known to be on girder A2001. In addition to stiffening the web, these stiffeners significantly increase the bending resistance of the flange. In a subsequent analysis where we removed the side plate described in the previous paragraph in order to allow for further westward travel of girder A2001, we found that the stresses in the girder flange and stiffener would not be sufficient to cause the flange to fail, thus preventing the girder from walking off its seat (Section 3.2.2).

Figure 3.6 Section view at Floor 13 of Column 79 and girder A2001 seated beam connection, which shows stiffener plates on girder A2001 (Data from Frankel Steel Limited, 1985, Drawing 9114; figure prepared by Brookman, 2012).

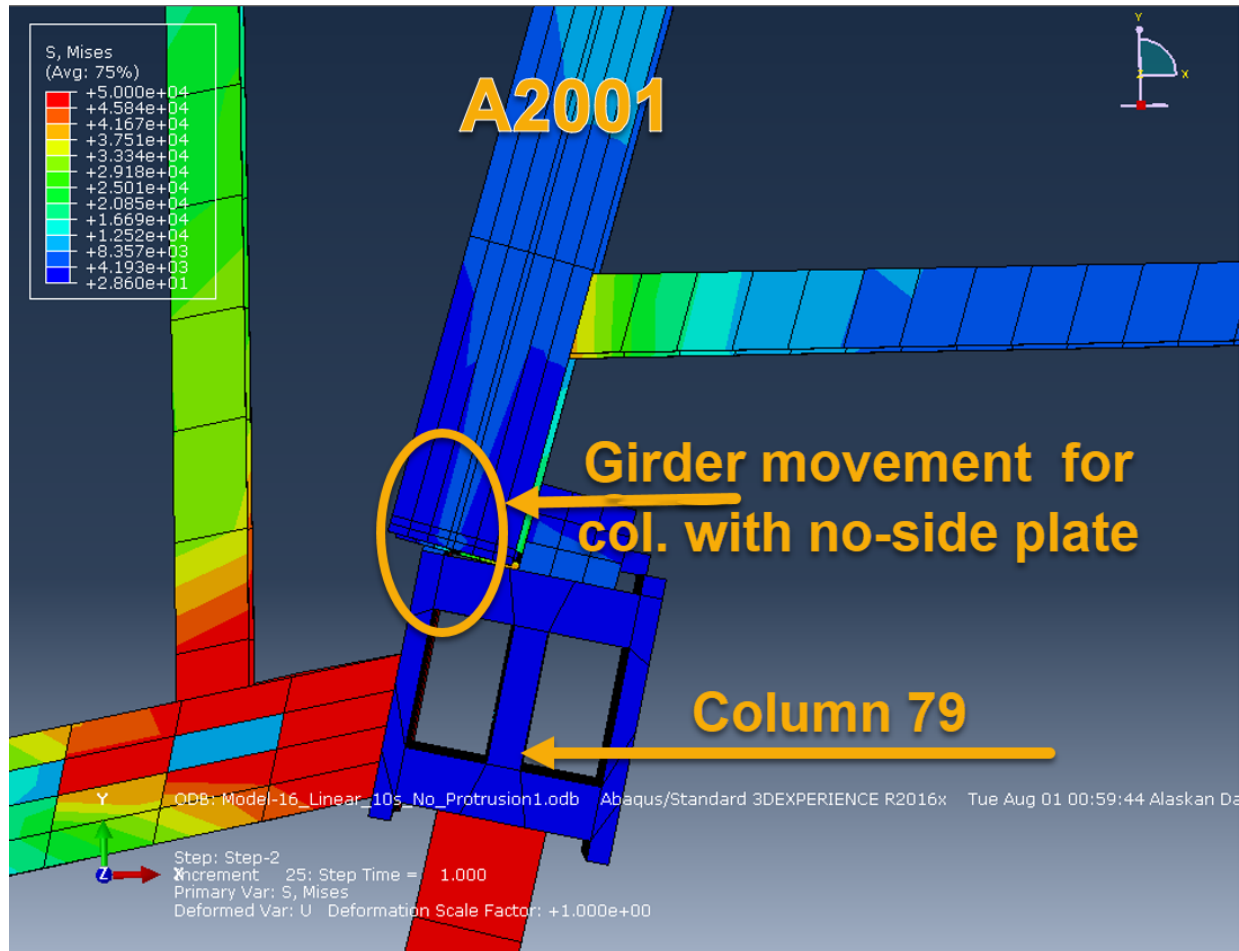
Figure 3.7 Plan view shows girder A2001 being pushed laterally past notched western side plate.

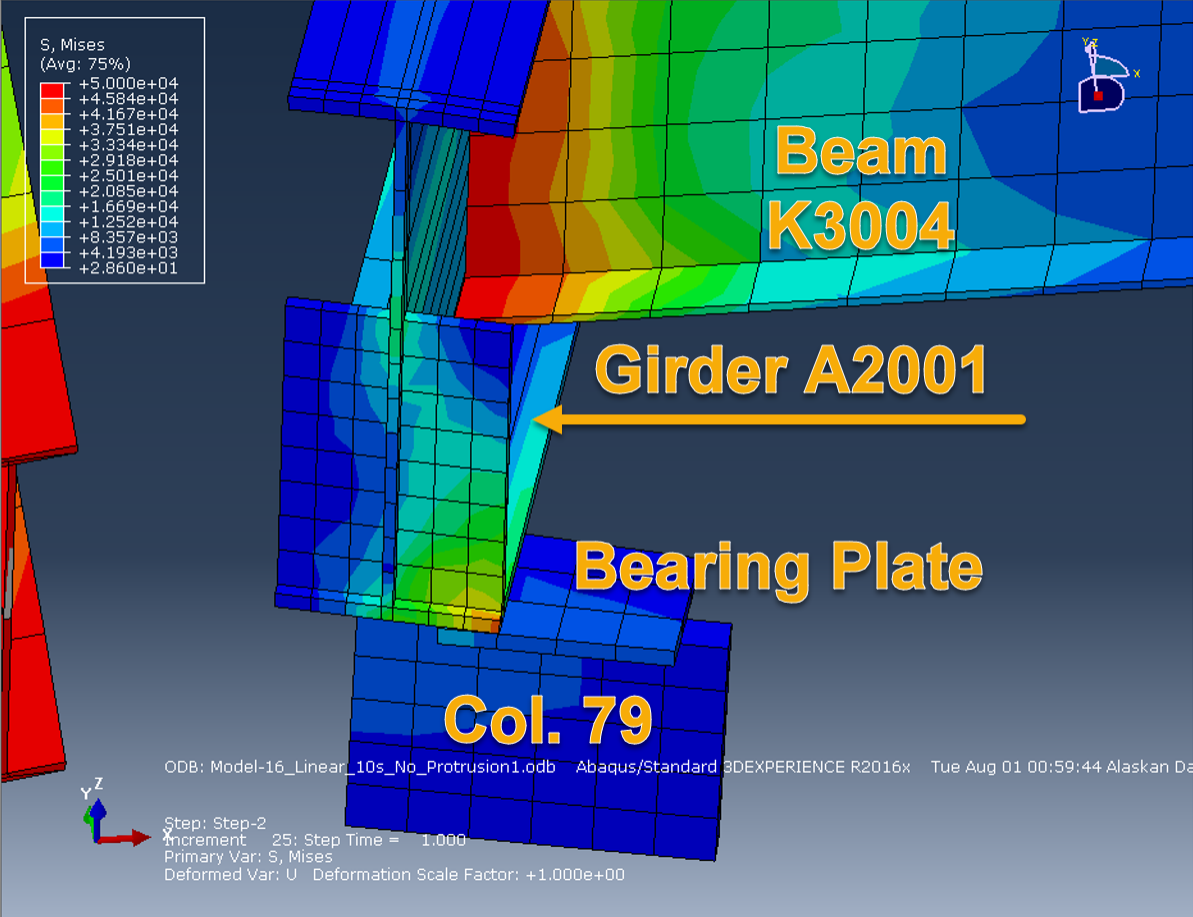
Figure 3.8 Analysis showing girder web A2001 pushed laterally past the bearing seat at Column 79. The column is removed for clarity.

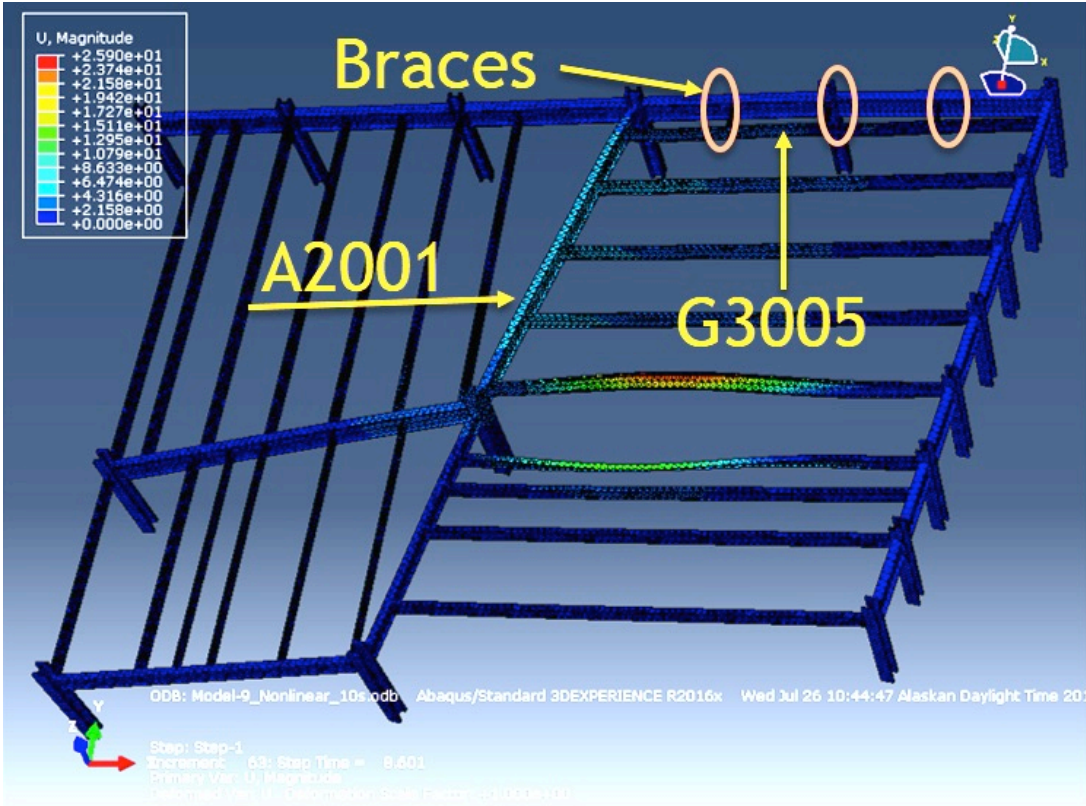
- In a preliminary collapse initiation hypothesis, NIST posited that beam G3005 buckled because its thermal expansion was restrained by girder A2001. We found that this can

happen only when the three lateral support beams S3007, G3007, and K3007 spanning from beam G3005 to the north exterior wall are not included in the model. While these short beams are observed in some of the figures in the NIST report, they are missing from the model(s) used in the thermal and structural analysis shown in the report (Section 3.2.3).

Figure 3.11 UAF ABAQUS analysis shows beam G3005 does not buckle when braced by lateral support beams S3007, G3007 and K3007 (Frankel Steel Limited, 1985).

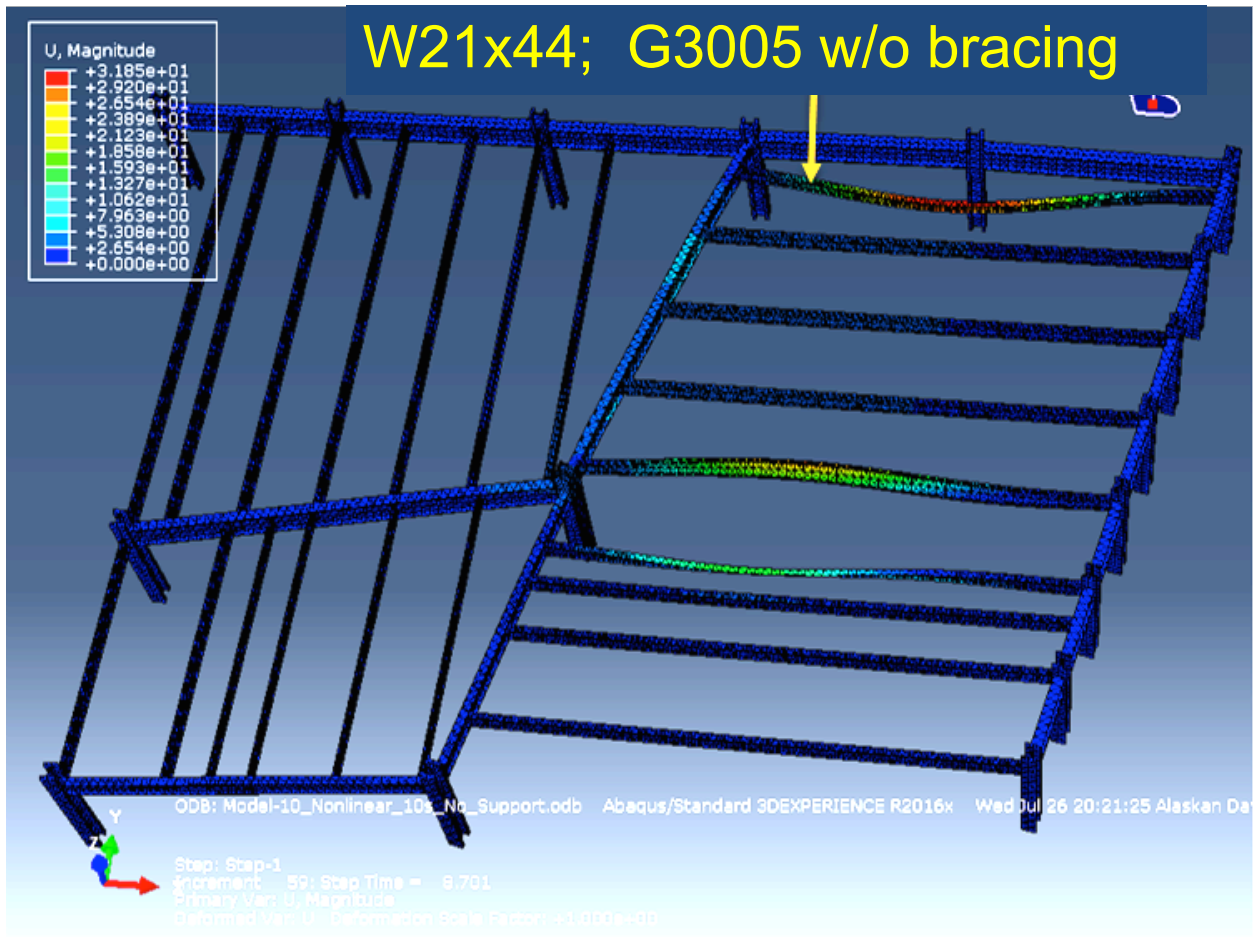
Figure 3.14 UAF analysis of the W21x44 G3005 with no lateral support beams included.

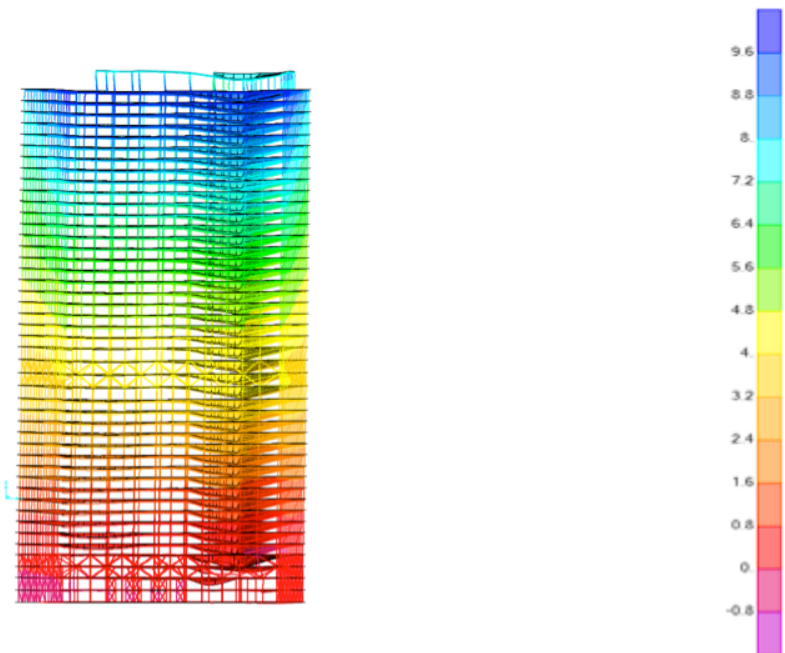
Figure 4.2 Columns 79, 80, and 81 are removed from Floor 6 to Floor 13. The key to the right is expressed in inches of movement. The building tilts to the east almost 10 inches. The penthouse does not collapse.

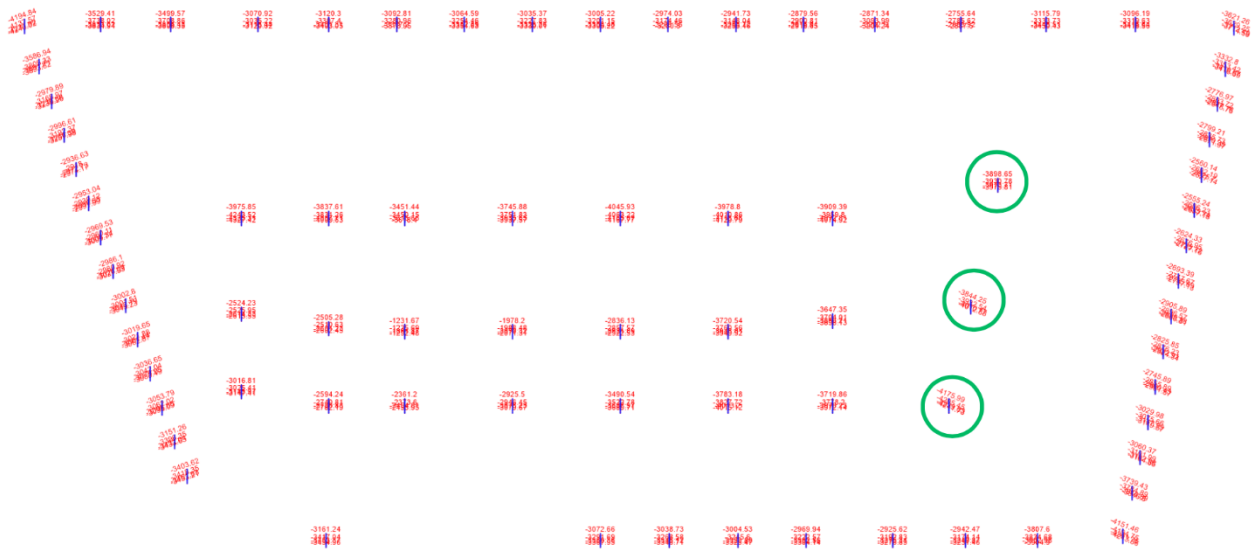
Figure 4.8 Linear static analysis of Columns 79 to 81 (circled in green) being removed.

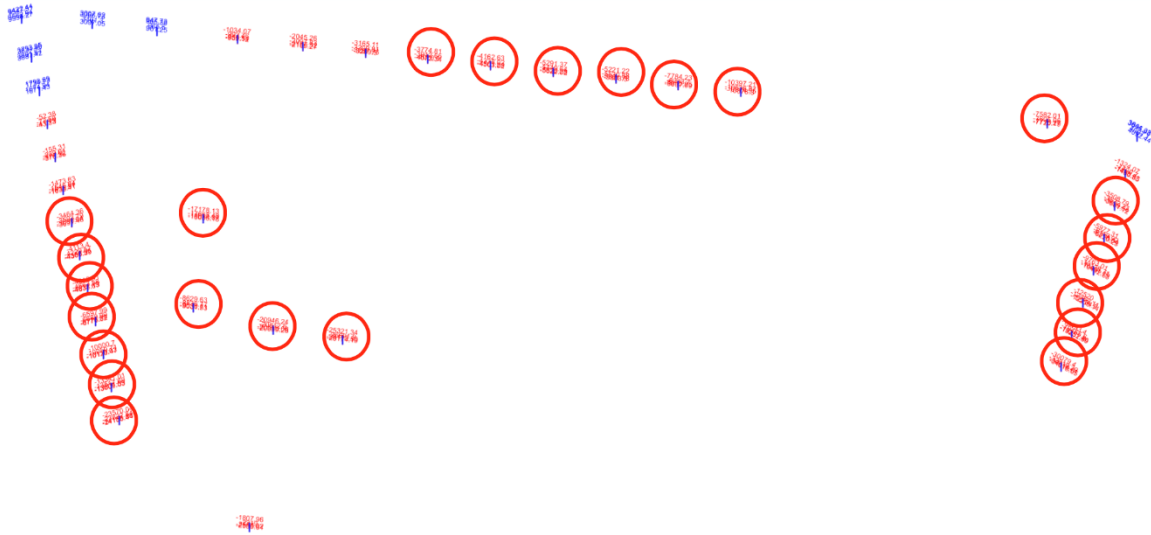
Figure 4.12 Linear static analysis results show that the failure of additional columns (shown in Figure 4.11 above) leads to the failure of the remaining core columns and many exterior columns (circled in red). The columns with blue values are in tension rather than compression, indicating the building is tipping away from those columns.

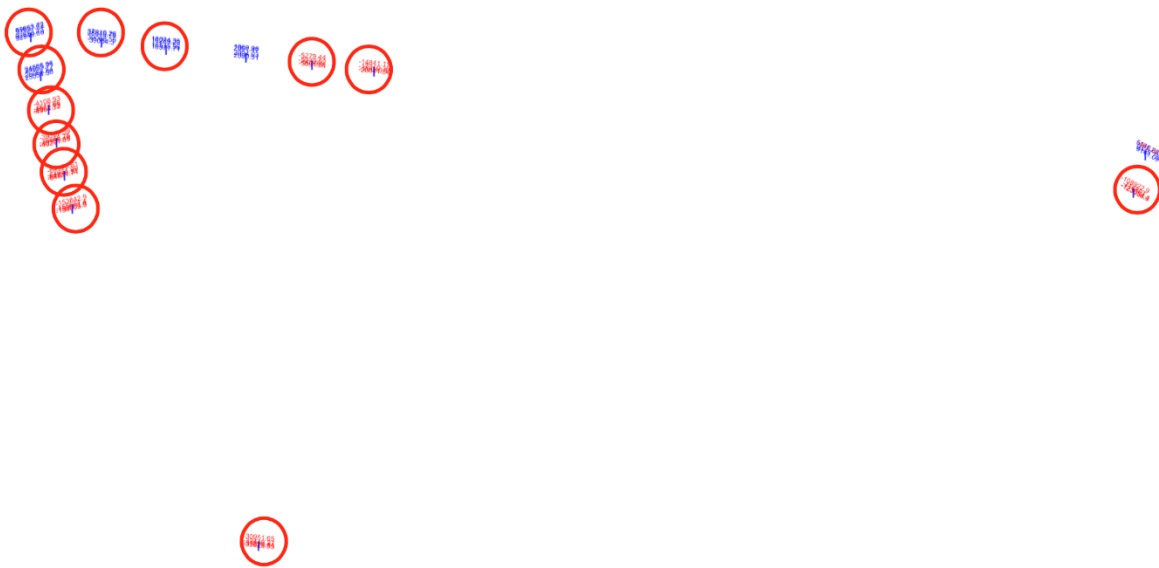
Figure 4.13 Linear static analysis results show that the failure of additional columns (shown in Figure 4.12 above) leads to the failure of nearly every remaining column (circled in red).

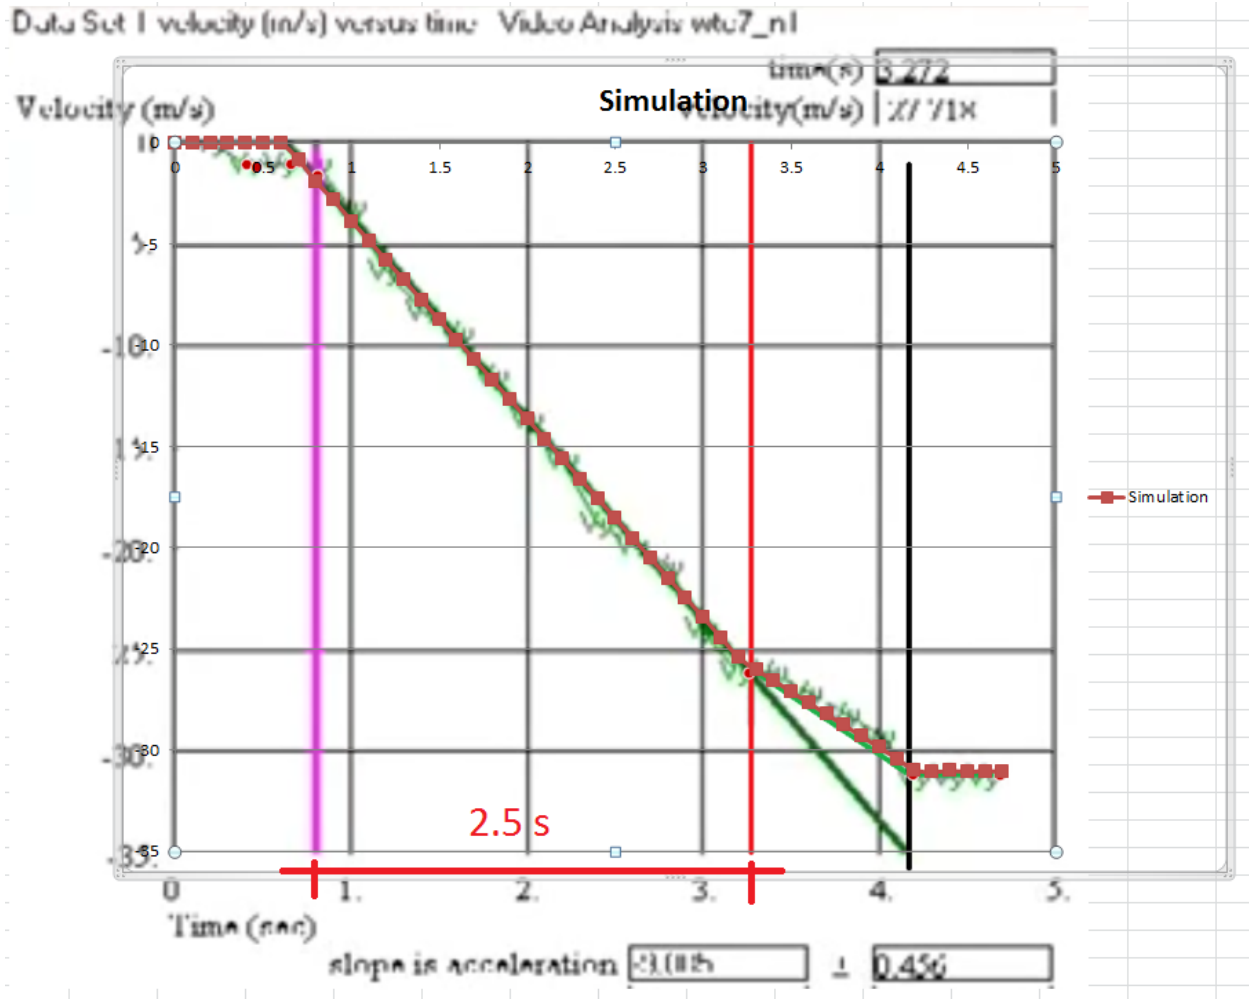
This conclusion is based primarily upon the finding that the simultaneous failure of all core columns over 8 stories followed 1.3 seconds later by the simultaneous failure of all exterior columns over 8 stories produces almost exactly the behavior observed in videos of the collapse, whereas no other sequence of failures that we simulated produced the observed behavior. We cannot completely rule out the possibility that an alternative scenario may have caused the observed collapse; however, the near-simultaneous failure of every column is the only scenario we identified that was capable of producing the observed behavior.

Figure 4.20 Velocity comparison between Chandler measurement (green plotted line) and UAF simulation (red plotted line). Bold green trend line illustrates free fall.
