A Structural Reevaluation of the Collapse of World Trade Center 7

Final Report

INE Report 18.17

March 2020

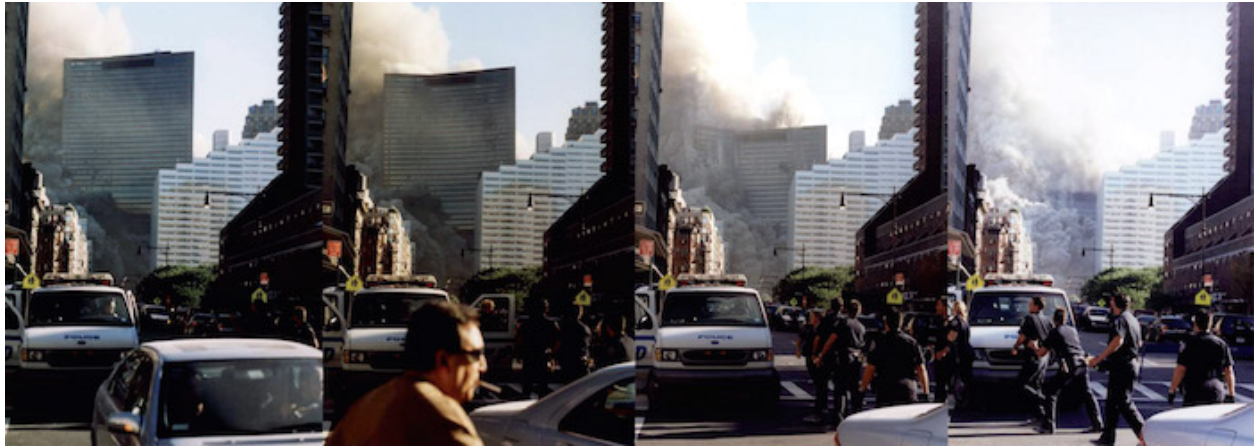
Figure 1.5 The collapse of WTC 7 at 5:20 PM (source unknown).

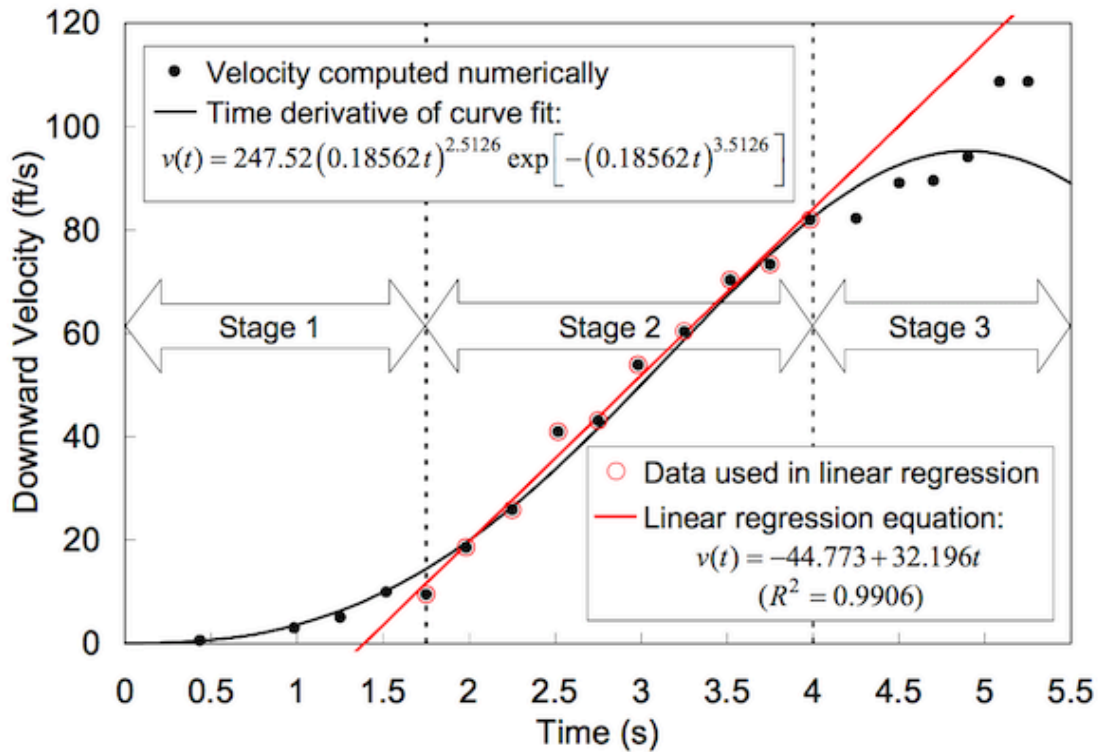
1. WTC 7 experienced between 2.25 and 2.5 seconds of free fall (i.e., gravitational acceleration) during its collapse. This fact was first identified by independent researcher David Chandler and later corroborated by NIST (Figure 1.6). WTC 7's free fall is noteworthy because, in a typical building collapse, WTC 7 would be expected to experience a combination of axial rotation and bending of members, resulting in a disjointed, asymmetrical collapse, at less than free-fall acceleration. Asymmetrical, tipping behavior is especially likely because WTC 7 did not have planar symmetry.

Figure 1.6 WTC 7 was in free fall for approximately 2.25 seconds over a distance of approximately 8 stories or 32.0 meters (NIST, 2008, NCSTAR 1A).

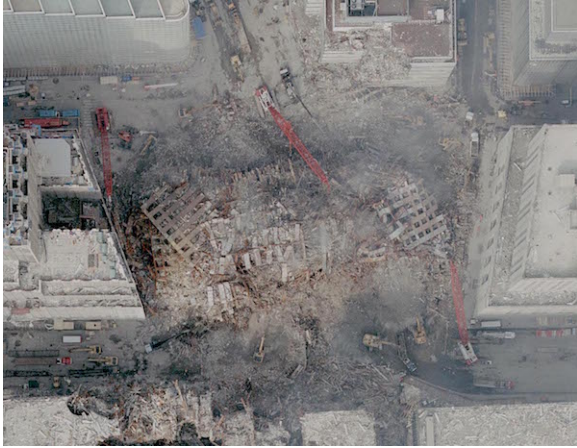
2. The debris pile of WTC 7 was contained mostly inside the building's footprint. Furthermore, it did not have large pieces of concrete flooring or intact structural framing that would be expected in a building collapse (see Figure 1.7).

Figure 1.7 WTC 7 debris pile (NOAA, September 23, 2001).

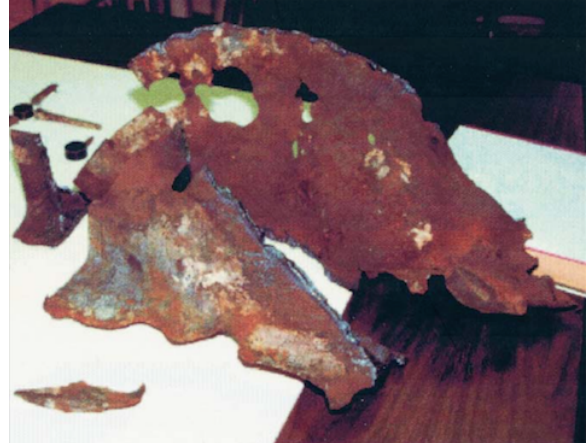
3. According to Appendix C of FEMA's May 2002 report, a steel member recovered from WTC 7 was found to have experienced corrosion due to a combination of oxidation and sulfidation at 1,000°C, resulting in the formation of a liquid eutectic (see Figure 1.8). Researchers have hypothesized that the presence of thermate, which is a form of thermite

incendiary that includes sulfur, would explain the sulfidation and formation of a liquid eutectic (Jones, 2006 and 2007).

Figure 1.8 Steel from WTC 7 that experienced oxidation and sulfidation (FEMA, 2002).

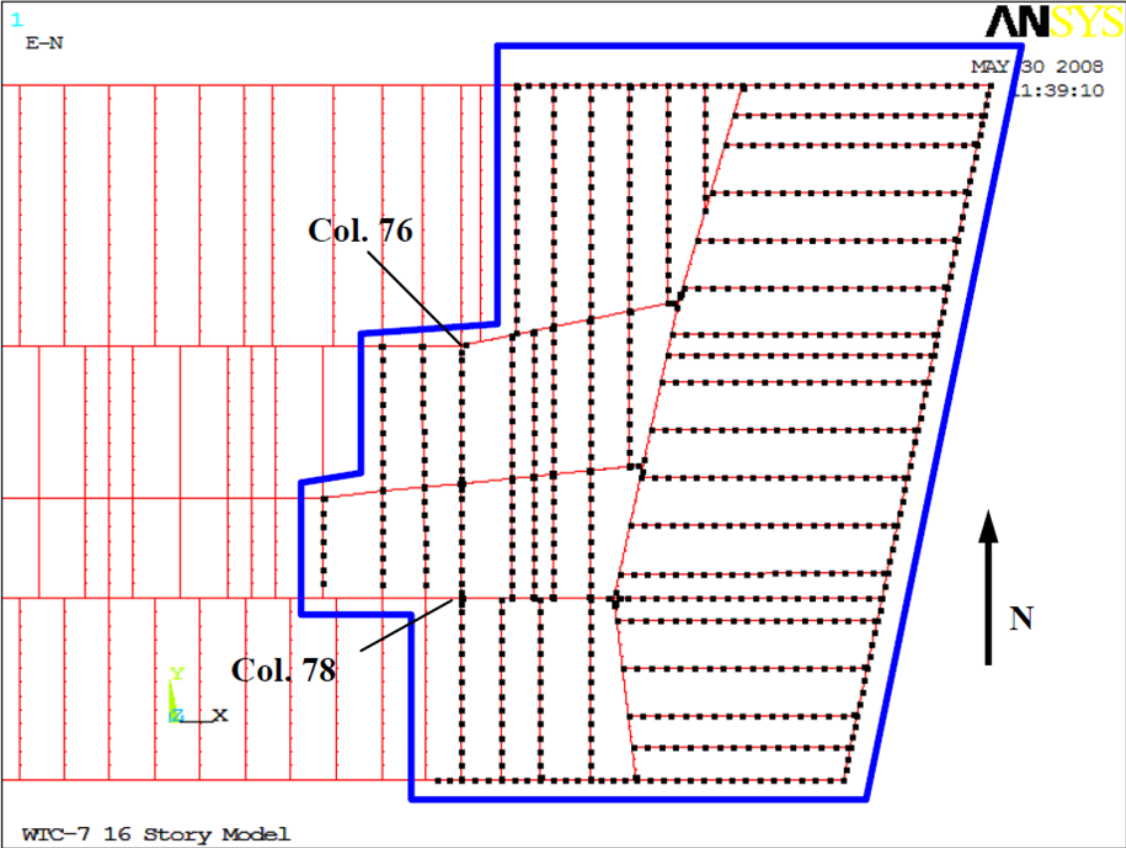
In the NIST investigation, the failures of the floor-framing connections and the shear studs were modeled with break elements on Floors 8 to 14. Outside the selected area in Figure 2.5 shown below, structural damage — such as buckling of the steel frame and crushing and

cracking of the concrete slab — was modeled over the entire floor, but connection failures were not modeled over the entire floor. Connections were also not modeled in the exterior moment frame, as no failures were observed there prior to the onset of global collapse (NIST, 2008, NCSTAR 1A).

Figure 2.5 Area of floor where connection failure was modeled by NIST

By not modeling connections in the outside frame, NIST overestimated the rigidity of the outside frame. That assumption and inconsistent modeling for the framing connections resulted in the stiffness of the east side of the building being different than that of the west side. This resulted in the stiffness being compromised across the plan of the building.

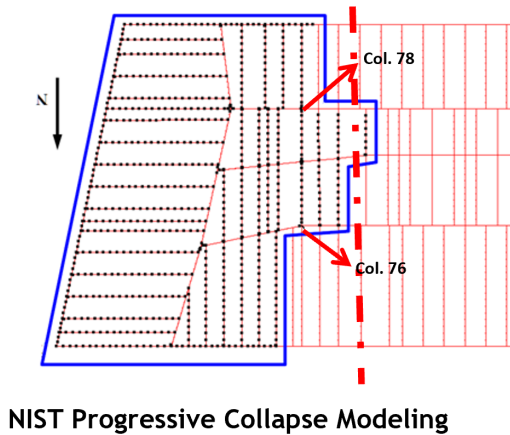
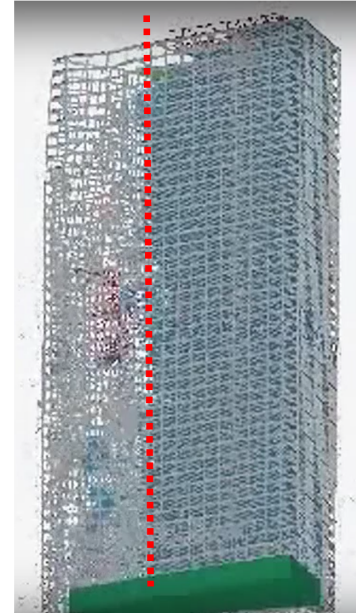
The NIST simulation of the collapse illustrated that the west side of the building acted differently from the east side. The structural response to failure would more closely resemble the actual collapse if the connections had been accounted for throughout the structural frame. By not modeling the connection failures outside the selected area shown in Figure 2.5 above, NIST appears to have reduced the stiffness in the area outside the selected area and separated its progressive collapse simulation into two parts (see Figure 2.6).

Connections were not modeled; outside selected blue space.

Figure 2.6 Progressive collapse separated into two parts.

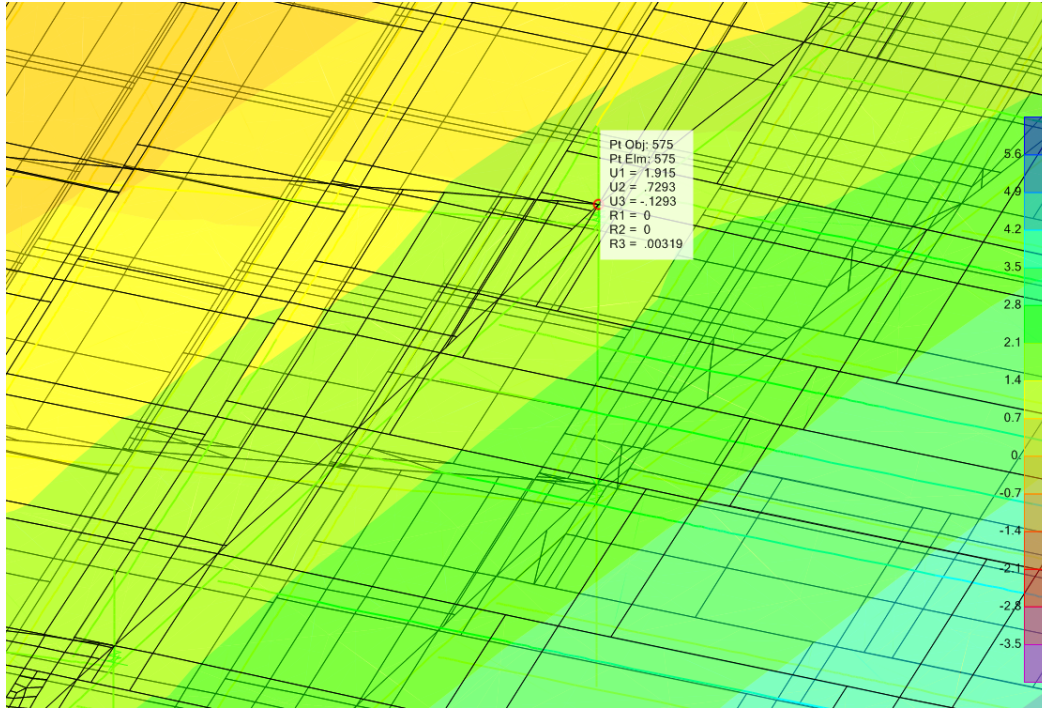
Figure 2.59 shows the displacement of the floor system surrounding Column 79. The displacement at Column 79 in the x -direction was 1.915 inches east (and not west), and the displacement at Column 79 in the y -direction was 0.7293 inches north. Note that this is the overall displacement of the floor system. The westward displacement of girder A2001 relative to Column 79 was found to be less than 1 inch, which differs substantially from the 6.25 inches of westward movement of girder A2001 reported by NIST. We believe this is because NIST treated the exterior frame as infinitely stiff and fixed it against horizontal movement. Our analysis was based on using the actual external frame stiffness, which was very flexible.

Figure 2.59 Displacement (inches) of the floor system surrounding Column 79.

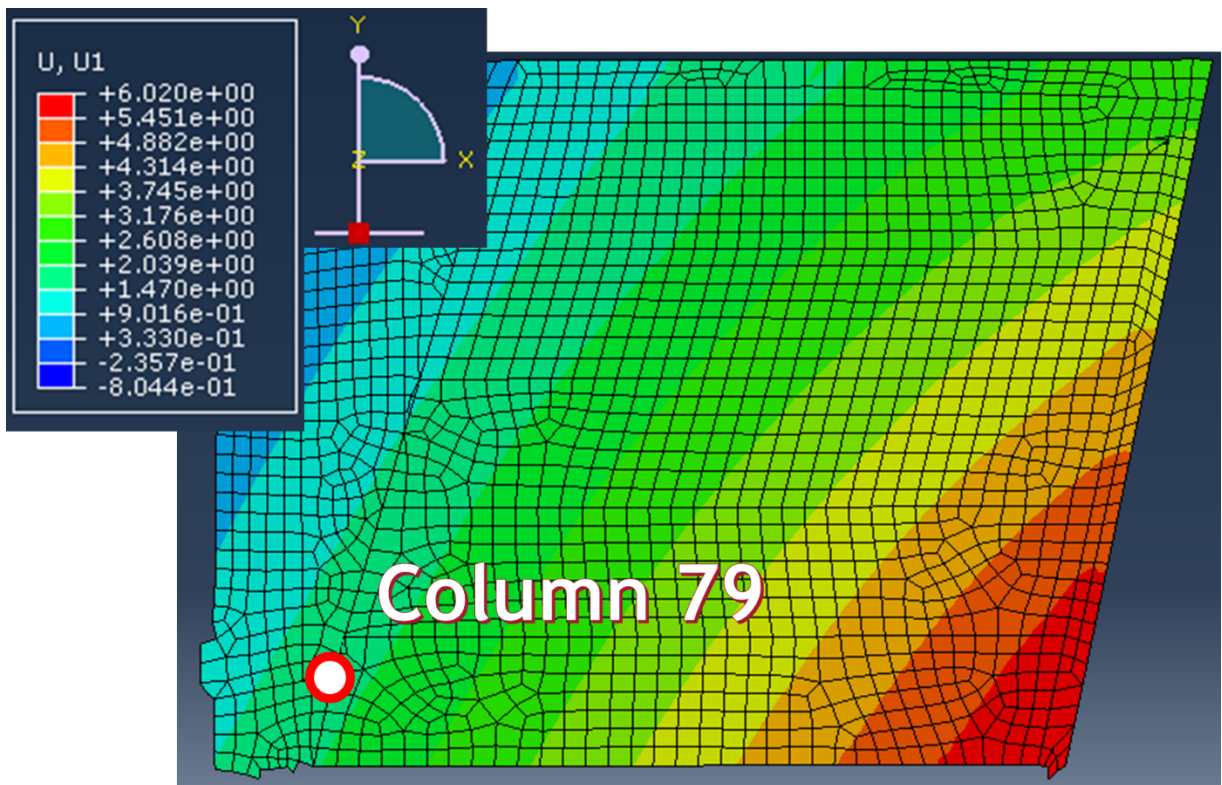
Figure 2.63 Movement (inches) in x-direction at Floor 13 around Column 79.

According to NIST, the initiating failure occurred at the connection between Column 79 and girder A2001 at Floor 13 due to a relative displacement of girder A2001 of 6.25 inches. Our ABAQUS analysis corroborated the findings of our SAP2000 analysis, showing that girder A2001 would undergo less than one inch of westward displacement relative to Column 79 under the worst-case fire condition. Examining all possible conditions, our analysis found that the westward movement of girder A2001 relative to the base plate on Column 79 was 3.68” for non-composite, 2.18” for partially composite and less than 1” for composite behavior (the condition at time of the fire).

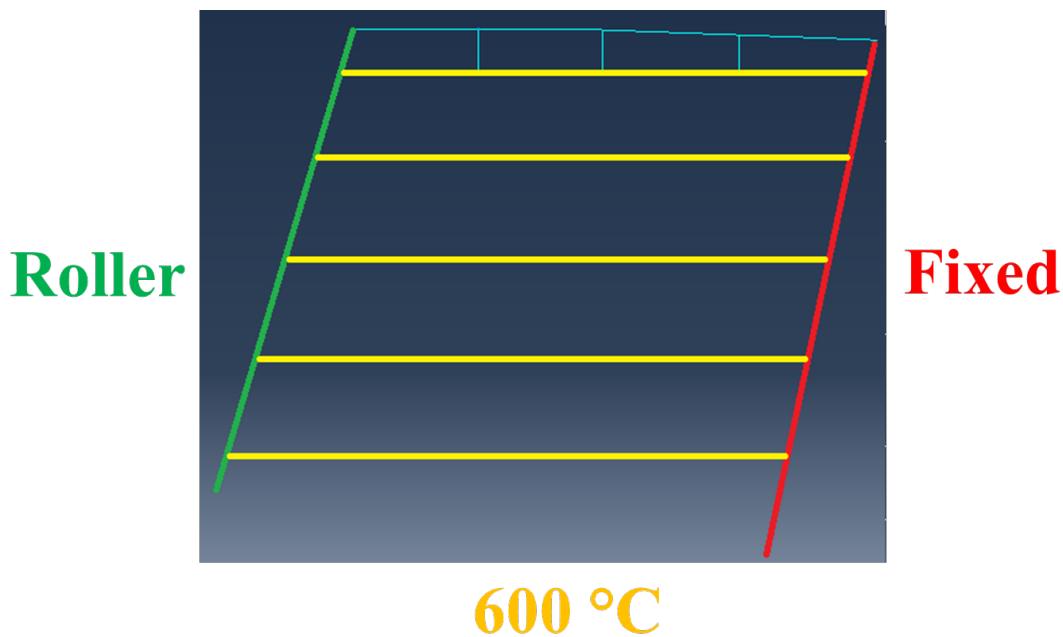
The boundary conditions reported by NIST and the assigned temperature distribution are shown in Figure 2.65 below. The concrete deck was not included in this model to ensure free expansion of the steel frame. The assigned temperature is also higher than the expected fire condition.

Figure 2.65 Local frame boundary conditions reported by NIST.

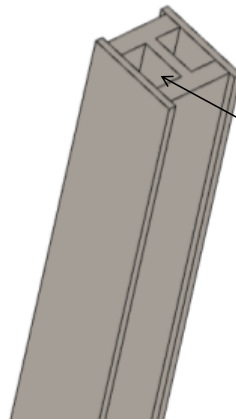
Figure 3.3 shows the built-up configuration of Column 79 with its protruding side plates. Using the assumptions made by NIST, we analyzed the thermal response of Floor 13.

Figure 3.3 Column 79 section showing side plates welded to a W14x730.

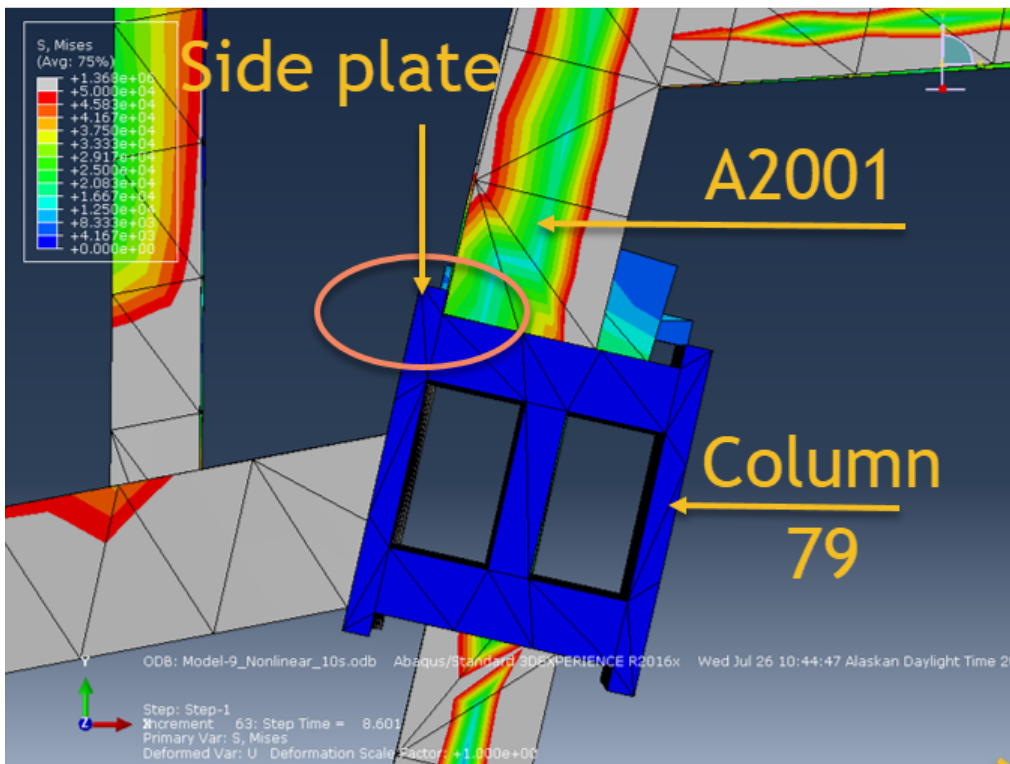
First, we found that when girder A2001 is heated, it expands axially towards column 79, such that it becomes trapped behind the side plate on the western side of Column 79 as it is pushed to the west by thermally expanded beams K3004, C3004, B3004, A3004, and G3005 (see Figures 3.1 and 3.4).

Figure 3.4 Plan view showing girder A2001 trapped by the Column 79 side plate.

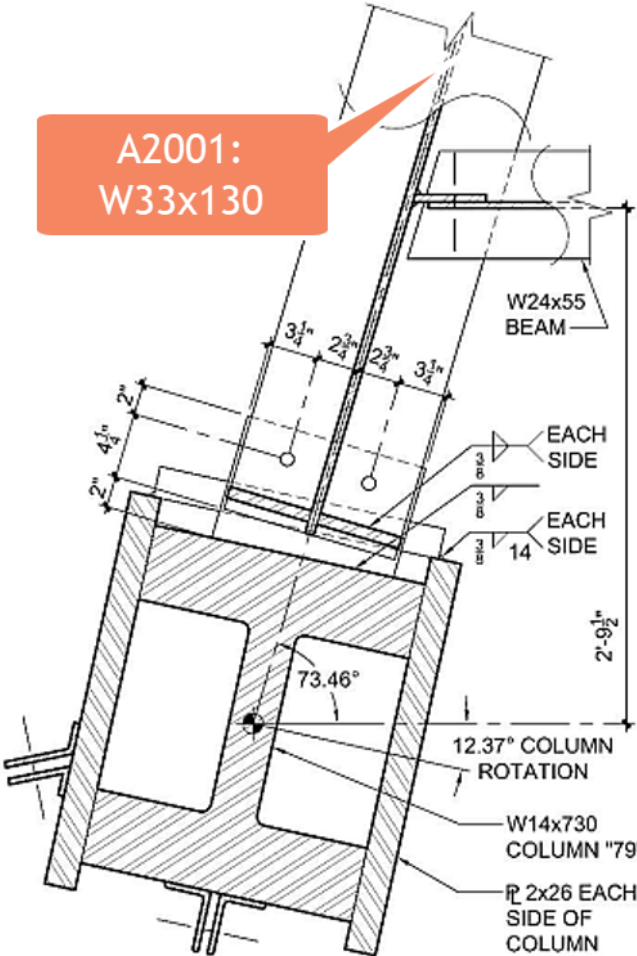
Figure 3.5 shows the girder bearing seat at Column 79 is 12 inches wide. The flange width for W33 x 130 girder A2001 is 11.510 inches wide and centered on the seat; its web is 0.580 inches thick. This would require a lateral travel distance of 6.290 inches for the web to be beyond the seat. However, the distance between the column side plates is 17.89 inches. The girder and bearing seat are slightly off center to the east, with just 3.678 inches between the girder's western edge and Column 79's western side plate. Thus, the side plate prevents the girder's web from traveling beyond the bearing seat.

Given that the Column 79 side plate prevents the girder's web from traveling beyond the bearing seat, it appears that the structural analysis performed by NIST either minimized the side plate protrusion on Column 79 (nominally 1.79 inches) or ignored it altogether.

Figure 3.5 Plan View for Floor 13 at Column 79 and girder A2001 seat connection (Data from Frankel Steel Limited, 1985, Drawing 9114; figure prepared by Brookman, 2012).

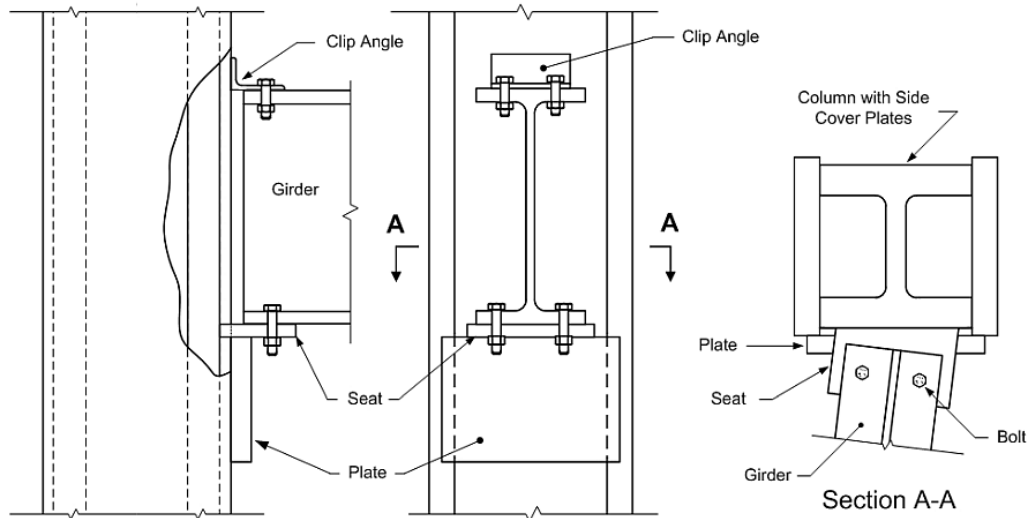
It is important to note that the analysis performed by NIST did not include the $\frac{3}{4}$ inch thick x 5.5 inch wide x 18 inch high partial height web stiffeners on girder A2001. Released fabrication shop drawing Frankel 9114 shows that the stiffeners were part of that structural member (Frankel Steel Limited, 1985). In addition to stiffening the web, these stiffeners significantly increase the bending resistance of the flange and would have prevented it from failing due to flexure (assuming the girder were somehow able to bypass the column side plate). Note that the small amount of high stress on the corner of the girder's flange is not in a load bearing area. This stress is due to the girder flange being slightly compressed in the axial

Figures 3.9 and 3.10 below, which are from the NIST report, show that the NIST report’s drawing and analysis figures omit these web stiffeners. Figures 3. 5 and 3.6 show the actual configuration.

Figure 3.9 Drawing of Column 79 and girder A2001 seated beam connection shown in Figure 8-21 of the NIST report.

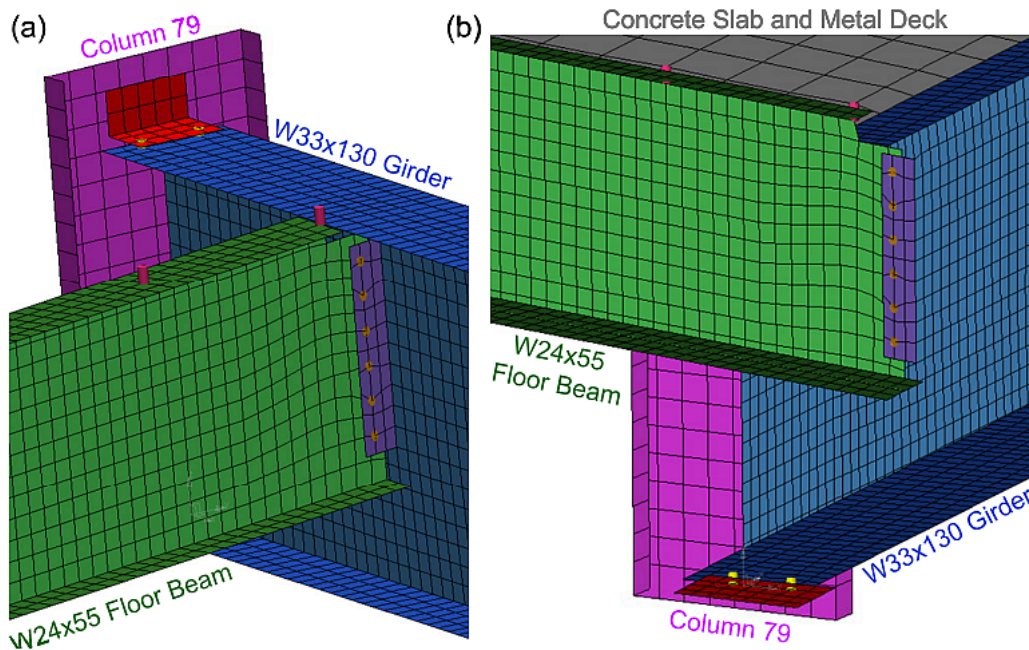
Figure 3.10 Figure 8-23 of the NIST report showing NIST’s finite element analysis of the Column 79 and girder A2001 seated beam connection.

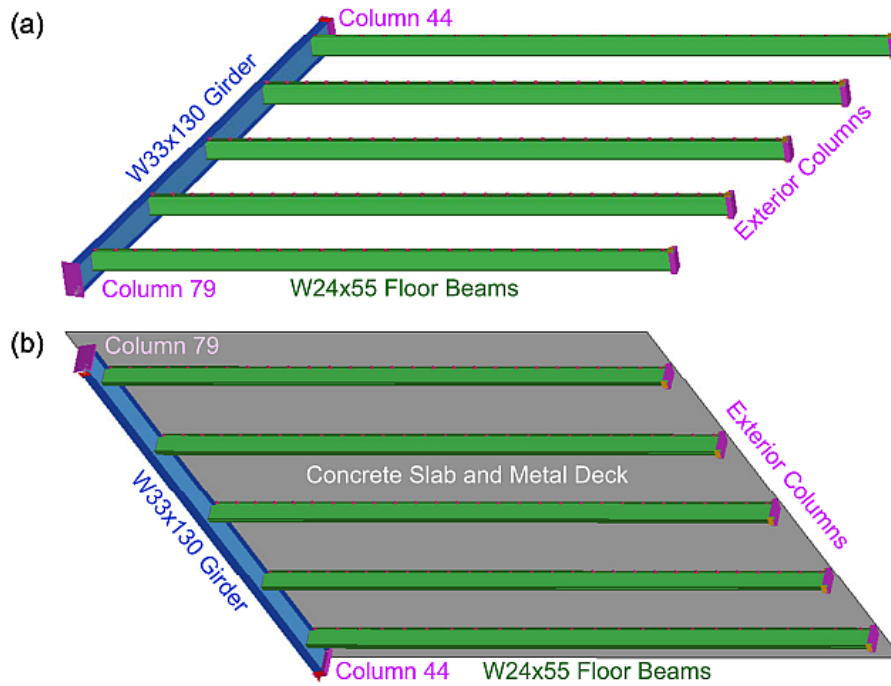
floor system was heated. The NIST report posits that beam G3005 buckled because its thermal expansion was restrained by girder A2001. Our analysis found that this can only happen when the three lateral support beams S3007, G3007, and K3007 spanning from beam G3005 to the north exterior wall are not included in the model. While these short beams are observed in some of the figures in the NIST report, they are missing from the model(s) used in the thermal and structural analyses shown in the report. It is important to realize that the lateral support beams have a significant effect and therefore should not have been omitted from the model(s).

Figure 3.12 Figure 8-22 in the NIST report shows model for girder A2001 and five beams to the east of it with no lateral bracing for beam G3005 (NIST, 2008, NCSTAR 1-9, Vol. 1, Page 350).

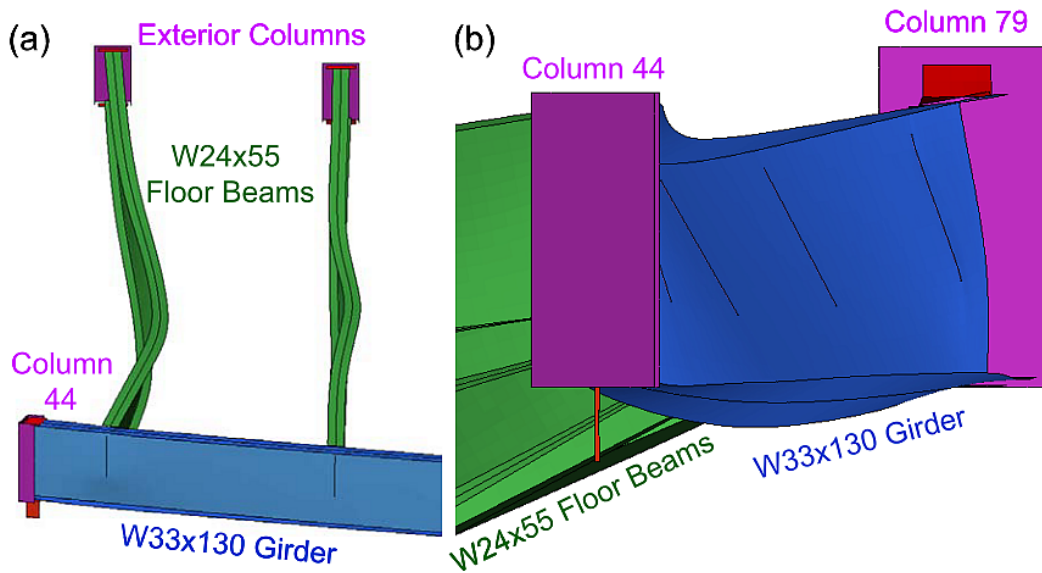
Figure 3.13 Figure 8-27 of the NIST report shows results of a finite element analysis where lateral support beams connecting to G3005 were not included (NIST, 2008, NCSTAR 1-9, Vol. 1, Page 354).

When the NIST constraints are followed, our analysis showed that beams D3004 and K3004 would have also buckled (see Figures 3.11 to 3.14). The NIST results were based upon erroneously selected boundary conditions, wherein NIST assumed the east exterior wall was extremely stiff and acted as a fixed restraint against thermal movements. As discussed previously, this was not the case.

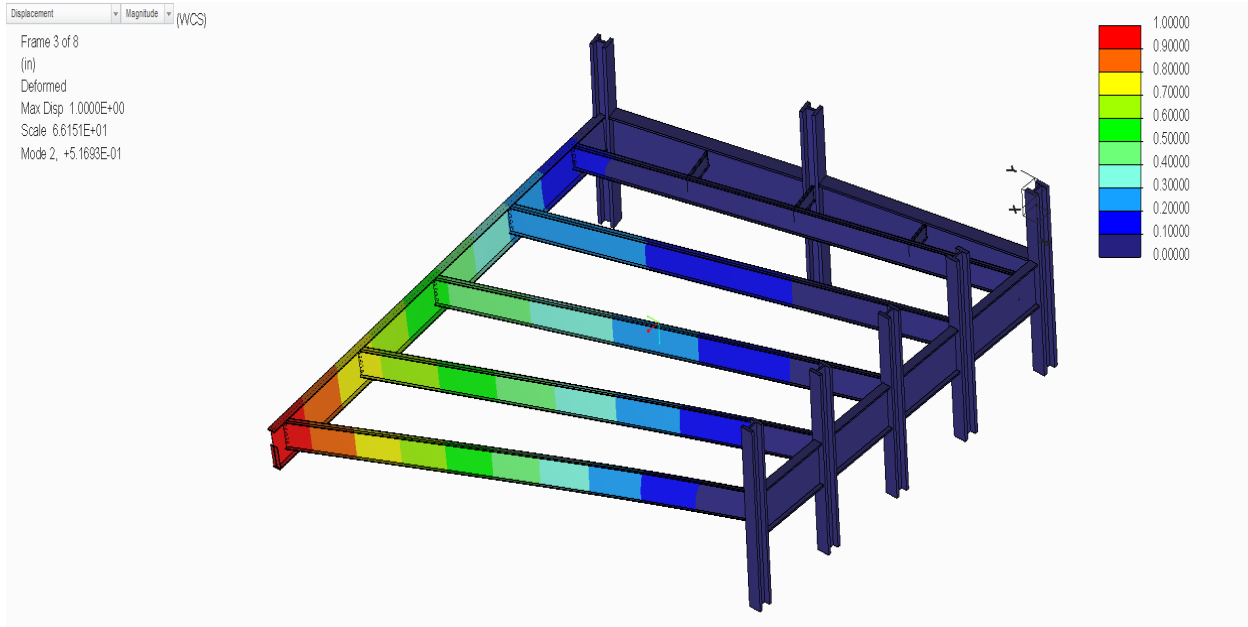
To determine the stiffness of the falling Floor 13 beam and girder assembly, a finite element modal analysis was performed with the assembly constrained at the north and east exterior walls and the girder sitting on its bearing seat at Column 44 with the bolts at the girder seat broken there. The results are shown in Figure 3.15. The first mode of 22 Hz involved only the beams moving in a transverse direction and was not relevant. The second mode of 0.52 Hz involved the participation of the entire beam and girder assembly in the vertical direction and was relevant.

Figure 3.15 The relevant 0.52 Hz mode of the falling beam and girder assembly.

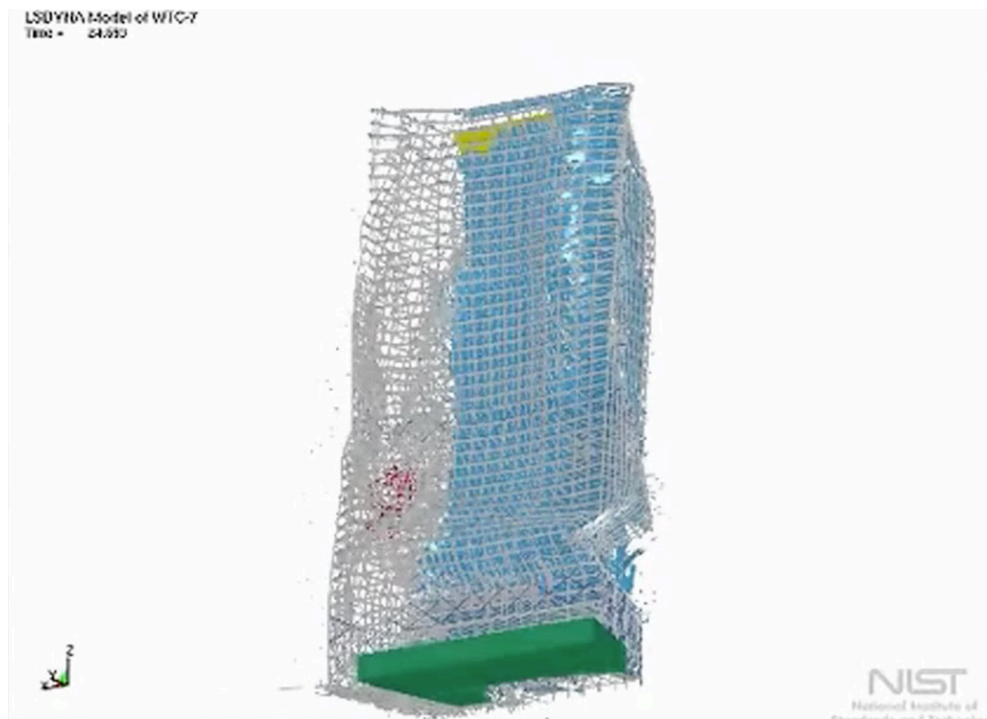
During our nonlinear connection study (Section 2.1.3.2), wherein we examined NIST's modeling of WTC 7's structural connections and its effect on NIST's progressive collapse simulation, we also observed that NIST's progressive collapse simulation did not closely resemble the observed collapse. While NIST's progressive collapse simulation does show the three key features listed above, it also predicts significant differential movements in the exterior, both before and during the fall of the roofline, that were not observed in the video (see Figures 4.1a and 4.1b). Such differential movements in the exterior would be extremely likely to have caused window breakage, cracking of the façade, and exterior deformation, none of which were observed. A major goal of our analysis was to identify failure mechanisms that would predict the minimal differential movement of the exterior seen in videos of the collapse. However, it should be noted that after the east penthouse collapse, window breakage did occur for 12 to 15 floors down from the top of the building under the penthouse. This was most likely caused by shock

Figure 4.1(b) NIST's progressive collapse simulation showing significant differential movements in the exterior (NIST NCSTAR 1A).
